Service bulletin

G214
EXPORT
1

THE BRITISH MOTOR CORPORATION (AUSTRALIA) PTY. LIMITED

GEAR CHANGE LINKAGE AND GEARBOX.

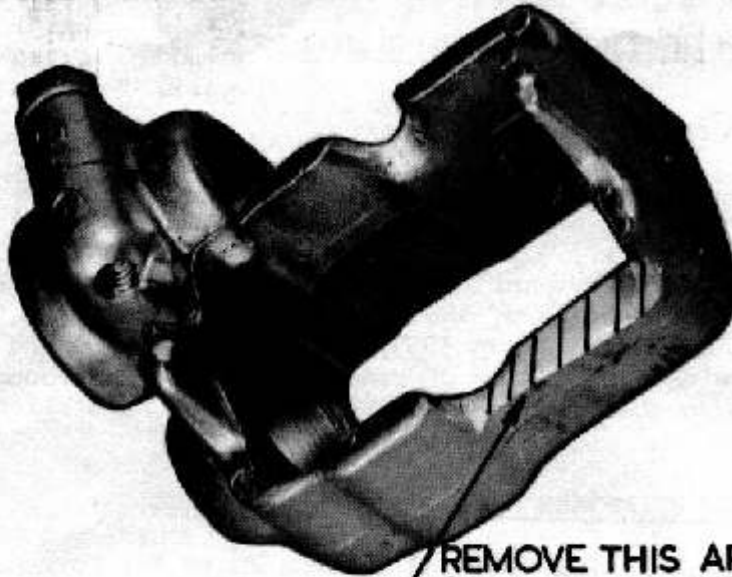
and reverse operating rod is not fouling on the bottom control rod bracket preventing full engagement of 1st gear. The illustration below outlines the section of the bracket to be removed by filing.

REMOVE THIS AREA BY
FILING TO DEPTH OF
EXISTING GROOVE
